**Flood Control Project Maintenance
Levee Inspections****LMA District Cover Sheet****Spring 2015 Levee Inspection Results****Reclamation District No. 0524 Middle Roberts Island**

Spring 2015 Levee Inspection Results

Reclamation District No. 0524 Middle Roberts Island

Waterway			Bank	Unit Miles
Unit No. 01 San Joaquin River			Left	6.20
	Spring (March - May)	Summer (June - August)	(September - November) Fall	Winter (December - February)
Unit Maintenance Rating (Fall Only)				
Date of Inspection	04/21/2015 - 04/21/2015			
DWR Inspector	Richard Willoughby			
Accompanied By	Mario Jaques RD 524

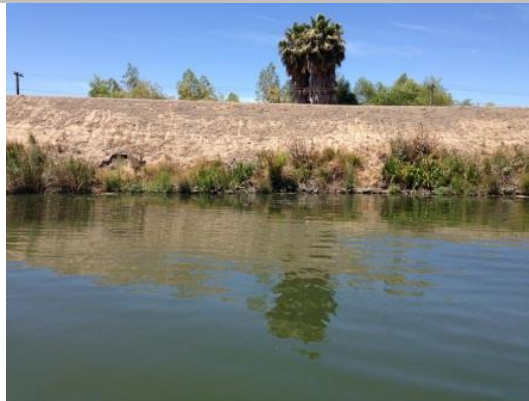
Photo 1 of 1 : SP_2015_RD0524_107_129_20150309_00129.jpg

LM Start	0.19	Rating **	U	Issue No.	129
LM End	0.19	Issue Type +	Ma	Location *	WS
Category	Supplemental			GPS Latitude/Longitude	
				Start	End
Item	DWR Erosion Survey			37.939085 °	37.939085 °
				-121.343917 °	-121.343917 °
DWR ID	DWR_RD0524_01_s_2015_129				
Action/Comments					
Inspector Comments: 6/19/2014: No significant change observed. 08/13/2013: The erosion was discovered during 2013 spring levee inspection. Inspector comment: Erosion is located along the lower level of water-ward slope. [2014 Site ID:RD0524U01RM40.85]

Close view of the erosion.

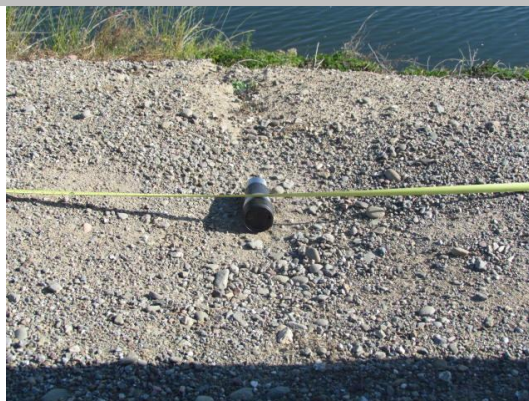
Photo 2 of 3 : SP_2015_RD0524_107_3_20150309_00007.jpg

LM Start	0.21	Rating **	M	Issue No.	3
LM End	0.21	Issue Type +	Ma	Location *	CR
Category	Earthen Levee			GPS Latitude/Longitude	
				Start	End
Item	Crown Surface / Depressions / Rutting			37.938890 °	37.938890 °
				-121.343657 °	-121.343657 °
DWR ID	DWR_RD0524_01_s_2012_3				
Action/Comments					
Repair depressions or ruts in the crown or slope. Inspector Comments: No change in status.

Looking west at depression on levee crown near waterward shoulder.

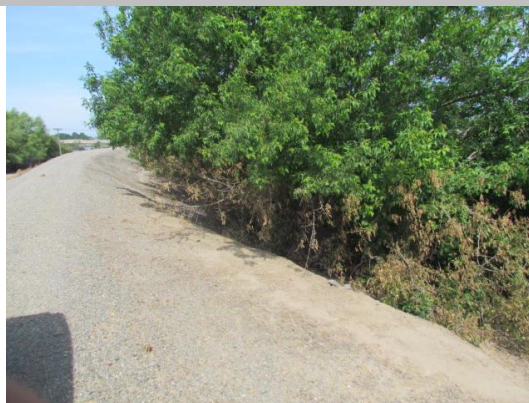
Photo 1 of 2 : SP_2015_RD0524_107_179_20150424_00204.jpg

LM Start	0.27	Rating **	U	Issue No.	179
LM End	0.27	Issue Type +	Ma	Location *	WS
Category	Earthen Levee			GPS Latitude/Longitude	
				Start	End
Item	Trim / Thin Trees			37.938438 °	37.938438 °
				-121.342883 °	-121.342883 °
DWR ID	DWR_RD0524_01_s_2014_179				
Action/Comments					
Thin trees to allow visibility of the ground and room to flood fight.

Looking north at untrimmed tree on waterward slope. (Spring 2015)

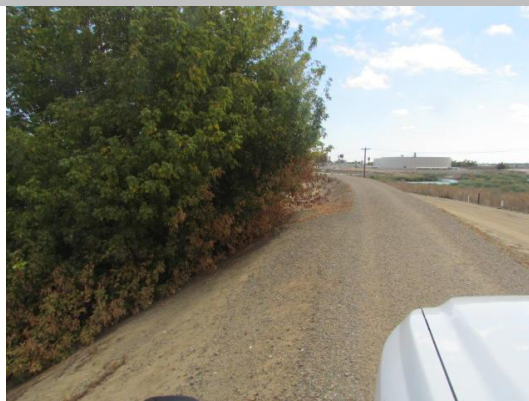
Photo 2 of 2 : SP_2015_RD0524_107_179_20150309_00146.jpg

Looking south at untrimmed tree on waterward slope. (Fall 2014)

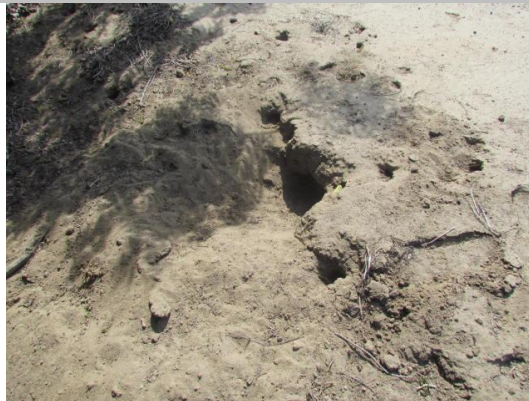
Photo 1 of 2 : SP_2015_RD0524_107_174_20150424_00205.jpg

LM Start	0.30	Rating **	U	Issue No.	174
LM End	0.30	Issue Type +	Ma	Location *	WS
Category	Earthen Levee			GPS Latitude/Longitude	
				Start	End
Item	Animal Control			37.938382 °	37.938382 °
				-121.342352 °	-121.342352 °
DWR ID	DWR_RD0524_01_f_2014_174				
Action/Comments					
No rodents visible, but rodent burrows visible; need to backfill and compact or grout burrows.					
Inspector Comments: Several rodent holes present at this site.

Looking west at several rodent holes on waterward shoulder. (Spring 2015)

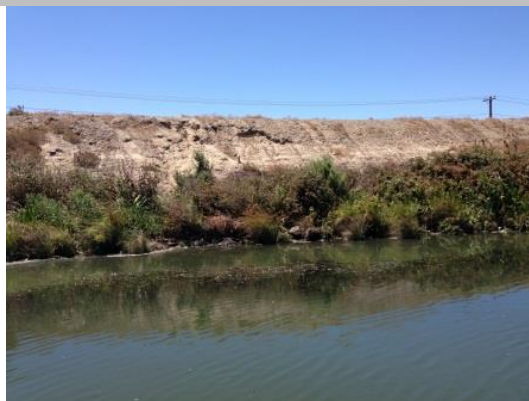
Photo 2 of 2 : SP_2015_RD0524_107_131_20150309_00130.jpg

LM Start	0.40	Rating **	U	Issue No.	131
LM End	0.40	Issue Type +	Ma	Location *	WS
Category	Supplemental			GPS Latitude/Longitude	
				Start	End
Item	DWR Erosion Survey			37.938870 °	37.938870 °
				-121.340460 °	-121.340460 °
DWR ID	DWR_RD0524_01_s_2015_131				
Action/Comments					
Inspector Comments: 6/19/2014: No significant change observed. 08/13/2013: No significant change at this site. 8/7/2012: The erosion is at the upper levee slope, and likely caused by slope slip. The lower levee slope is covered with dense vegetation. [2014 Site ID:RD0524U01RM40.99] 4/21/2015 Site repaired.

Front view of the erosion site. Note the vegetation at the levee toe and lower slope.

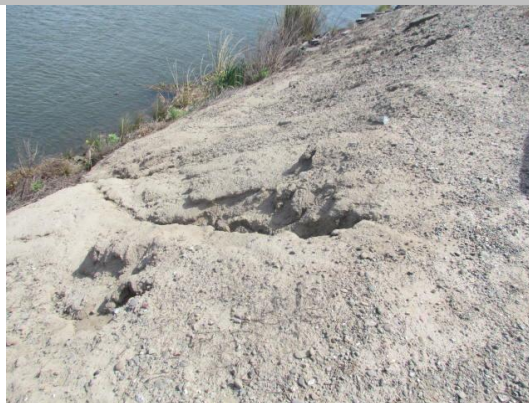
Photo 2 of 2 : SP_2015_RD0524_107_170_20150424_00208.jpg

LM Start	0.41	Rating **	M	Issue No.	170
LM End	0.65	Issue Type +	Ma	Location *	WS
Category	Earthen Levee			GPS Latitude/Longitude	
				Start	End
Item	Slope Stability			37.938628 °	37.938015 °
				-121.340385 °	-121.336165 °
DWR ID	DWR_RD0524_01_s_2015_170				
Action/Comments					
Repair slope instability. Inspector Comments: Several slope instabilities within this reach.

Looking west at waterward slope erosion.

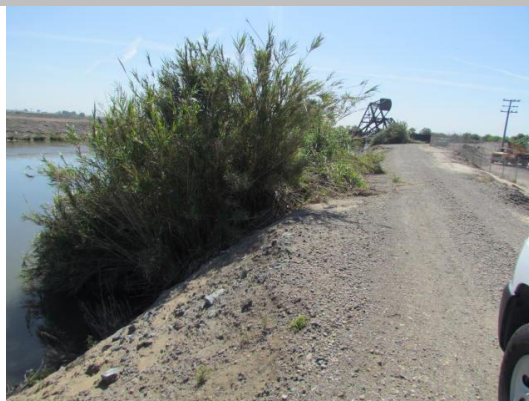
Photo 1 of 3 : SP_2015_RD0524_107_11_20150309_00013.jpg

LM Start	0.62	Rating **	M	Issue No.	11
LM End	0.63	Issue Type +	Ma	Location *	WS
Category	Earthen Levee			GPS Latitude/Longitude	
				Start	End
Item	Vegetation			37.938278 °	37.938247 °
				-121.336524 °	-121.336503 °
DWR ID	DWR_RD0524_01_s_2012_11				
Action/Comments					
Remove the wild growth other than native grasses from the levee slopes.					
Inspector Comments: Bamboo on waterward slope.

Looking southeast at bamboo on waterside slope. (Spring 2012)

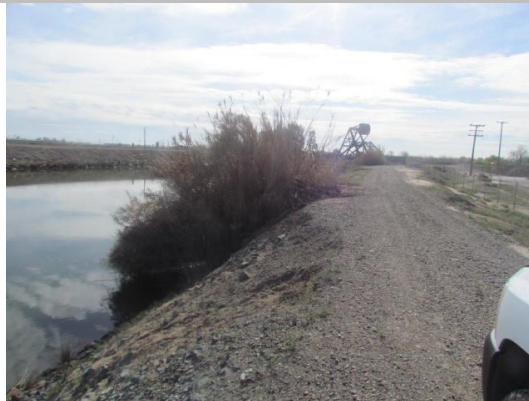
Photo 2 of 3 : SP_2015_RD0524_107_11_20150309_00014.jpg

Looking south at dying bamboo on waterward slope. (Spring 2013)

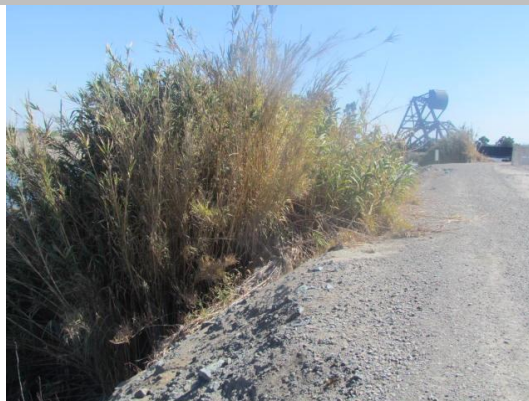
Photo 3 of 3 : SP_2015_RD0524_107_11_20150309_00015.jpg

Looking south at bamboo on waterside slope. (Fall Inspection 2012)

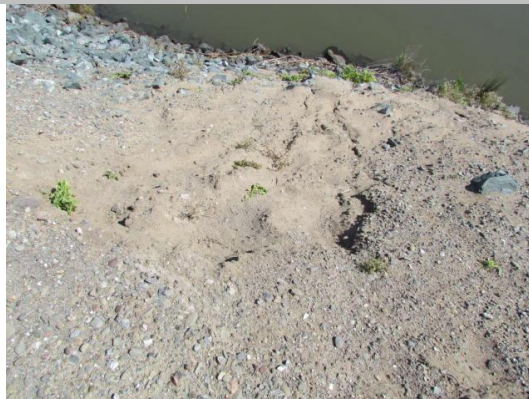
Photo 1 of 1 : SP_2015_RD0524_107_10_20150309_00012.jpg

LM Start	0.63	Rating **	M	Issue No.	10
LM End	0.63	Issue Type +	Ma	Location *	WS
Category	Earthen Levee			GPS Latitude/Longitude	
				Start	End
Item	Slope Stability			37.938247 °	37.938247 °
				-121.336503 °	-121.336503 °
DWR ID	DWR_RD0524_01_s_2012_10				
Action/Comments					
Repair the levee slope damaged by foot traffic and prevent access where possible.

Looking east at waterside erosion appears to be caused by runoff.

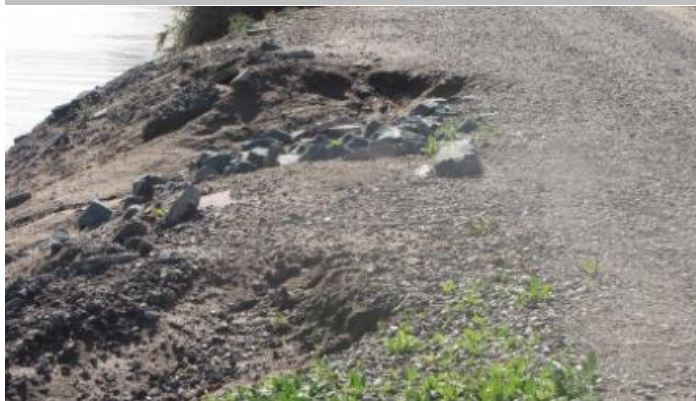
Photo 2 of 3 : SP_2015_RD0524_107_13_20150309_00018.jpg

LM Start	0.64	Rating **	M	Issue No.	13
LM End	0.65	Issue Type +	Ma	Location *	WS
Category	Earthen Levee			GPS Latitude/Longitude	
				Start	End
Item	Slope Stability			37.938105 °	37.938023 °
				-121.336288 °	-121.336173 °
DWR ID	DWR_RD0524_01_s_2012_13				
Action/Comments					
Repair slope instability.					
Inspector Comments: Erosion extends from mid levee slope to shoulder.

Looking south at erosion on waterside shoulder.

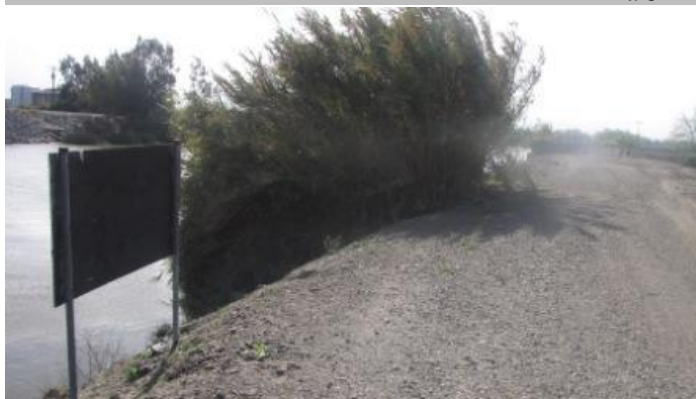
Photo 1 of 3 : SP_2015_RD0524_107_14_20150309_00020.jpg

LM Start	0.67	Rating **	M	Issue No.	14
LM End	0.67	Issue Type +	Ma	Location *	WS
Category	Earthen Levee			GPS Latitude/Longitude	
				Start	End
Item	Vegetation			37.937808 °	37.937808 °
				-121.335913 °	-121.335913 °
DWR ID	DWR_RD0524_01_s_2012_14				
Action/Comments					
Remove the wild growth other than native grasses from the levee slopes.					
Inspector Comments: Bamboo on waterward slope.

Looking southeast at bamboo on waterside shoulder as of 4/2010.

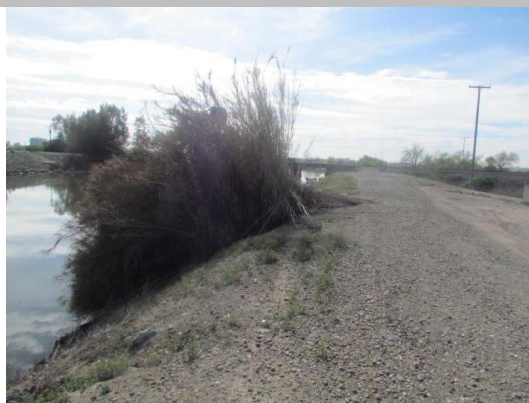
Photo 2 of 3 : SP_2015_RD0524_107_14_20150309_00021.jpg

Looking south at dying bamboo on waterward slope. (Spring 2013)

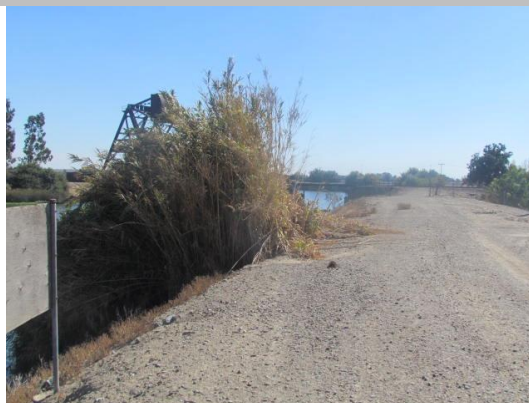
Photo 3 of 3 : SP_2015_RD0524_107_14_20150309_00022.jpg

Looking south at bamboo on waterside slope. (Fall 2012)

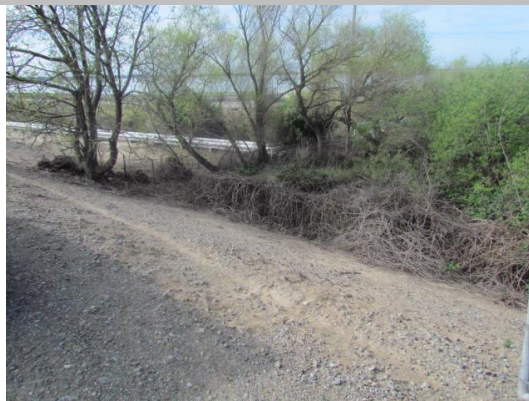
Photo 1 of 2 : SP_2015_RD0524_107_262_20150309_00155.jpg

LM Start	0.77	Rating **	M	Issue No.	262
LM End	0.77	Issue Type +	Ma	Location *	LS
Category	Earthen Levee			GPS Latitude/Longitude	
				Start	End
Item	Vegetation			37.936555 °	37.936555 °
				-121.334847 °	-121.334847 °
DWR ID	DWR_RD0524_01_s _ 2012_262				
Action/Comments					
Remove the wild growth other than native grasses from the levee slopes.					
Inspector Comments: Dense vegetation at landside toe along fence line.

Looking southwest at vegetation on landward slope and toe. (Spring 2013)

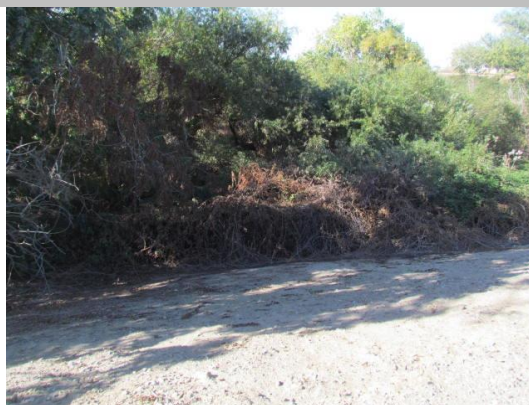
Photo 2 of 2 : SP_2015_RD0524_107_262_20150309_00156.jpg

Looking west at dense vegetation on landside toe.

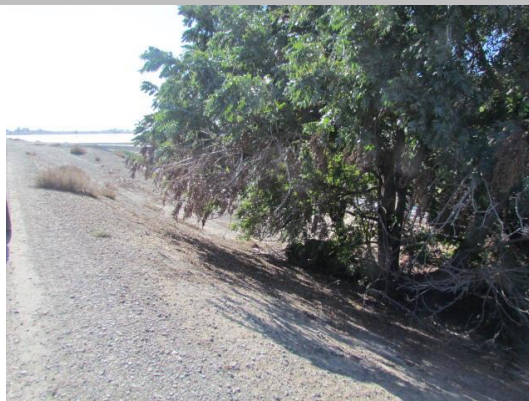
Photo 1 of 1 : SP_2015_RD0524_107_76_20150309_00088.jpg

LM Start	0.78	Rating **	M	Issue No.	76
LM End	0.78	Issue Type +	Ma	Location *	LS
Category	Earthen Levee			GPS Latitude/Longitude	
				Start	End
Item	Trim / Thin Trees			37.936444 °	37.936444 °
				-121.334797 °	-121.334797 °
DWR ID	DWR_RD0524_01_s _ 2012_76				
Action/Comments					
Trim trees to at least five feet above ground level.

Looking southwest at low hanging tree branches at landside toe.

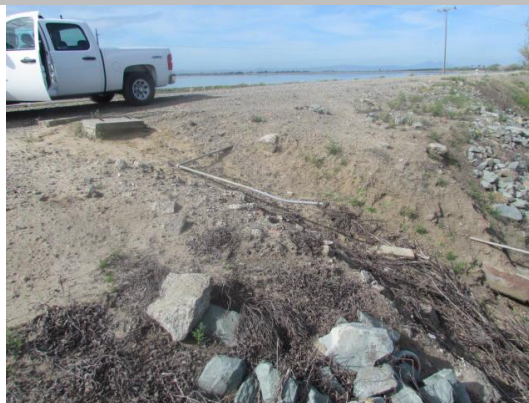
Photo 1 of 1 : SP_2015_RD0524_107_122_20150309_00124.jpg

LM Start	0.92	Rating **	M	Issue No.	122
LM End	0.92	Issue Type +	Ma	Location *	WS
Category	Earthen Levee			GPS Latitude/Longitude	
				Start	End
Item	Encroachments			37.935267 °	37.935267 °
				-121.332985 °	-121.332985 °
DWR ID	DWR_RD0524_01_s _ 2013_122				
Action/Comments					
Pipe					
Inspector Comments: Inch and half metal pipe should be removed.

Looking northwest at inch and half metal pipe on waterward slope.

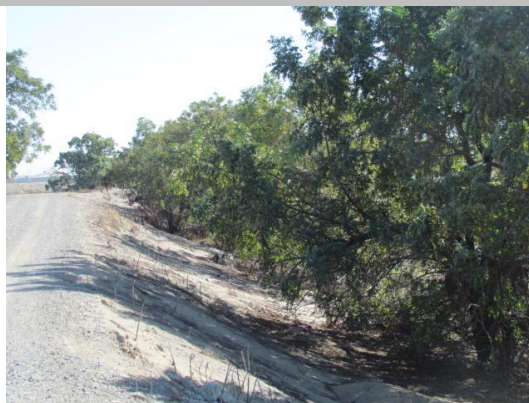
Photo 1 of 1 : SP_2015_RD0524_107_77_20150309_00089.jpg

LM Start	0.93	Rating **	M	Issue No.	77
LM End	1.01	Issue Type +	Ma	Location *	LS
Category	Earthen Levee			GPS Latitude/Longitude	
				Start	End
Item	Trim / Thin Trees			37.935259 °	37.935049 °
				-121.332864 °	-121.331334 °
DWR ID	DWR_RD0524_01_s _ 2012_77				
Action/Comments					
Trim trees to at least five feet above ground level.

Looking south at low hanging tree branches at landside toe.

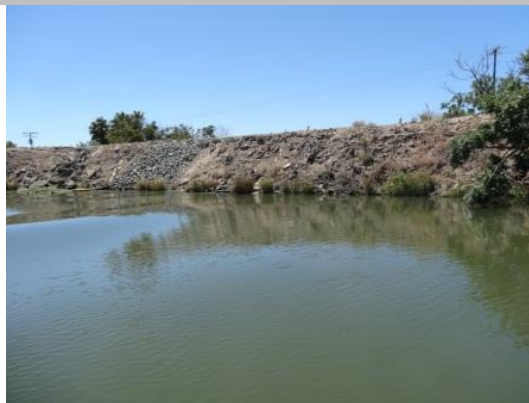
Photo 1 of 1 : SP_2015_RD0524_107_139_20150309_00136.jpg

LM Start	1.00	Rating **	U	Issue No.	139
LM End	1.00	Issue Type +	Ma	Location *	WS
Category	Supplemental			GPS Latitude/Longitude	
				Start	End
Item	DWR Erosion Survey			37.935326 °	37.935326 °
				-121.331537 °	-121.331537 °
DWR ID	DWR_RD0524_01_s _ 2015_139				
Action/Comments					
Inspector Comments: 6/19/2014: No significant change observed. 08/13/2013: No significant change at this site. 08/07/2012: The site has been visited by boat survey. Site has been repaired, but new erosion occurred at the levee slope and immediately upstream of the repaired site. 08/23/2011: The site is about 500 ft downstream of bridge. The levee

Front view of the site.

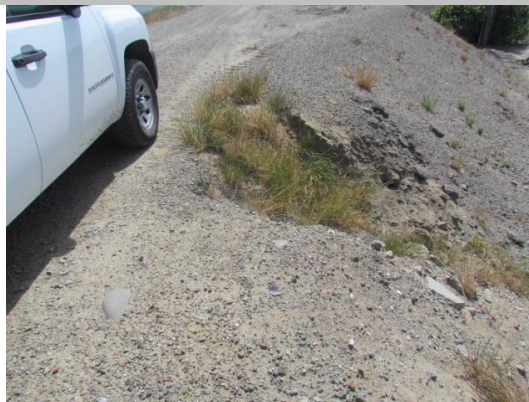
Photo 1 of 6 : SP_2015_RD0524_107_18_20150424_00209.jpg

LM Start	1.08	Rating **	M	Issue No.	18
LM End	1.08	Issue Type +	Ma	Location *	LS
Category	Earthen Levee			GPS Latitude/Longitude	
				Start	End
Item	Slope Stability			37.934645 °	37.934645 °
				-121.330310 °	-121.330310 °
DWR ID	DWR_RD0524_01_s _ 2012_18				
Action/Comments					
Repair slope instability. Inspector Comments: Slope damage extend from shoulder to middle of slope.

Looking south at caving on landward shoulder. (Spring 2015)

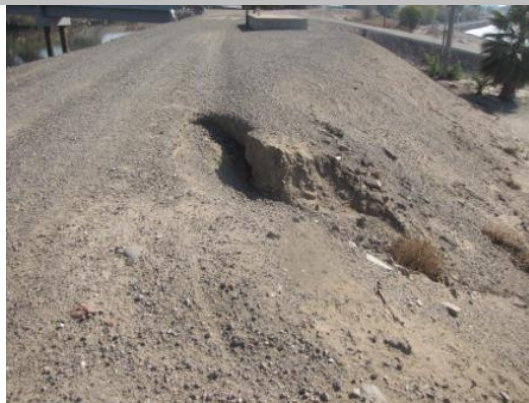
Photo 3 of 6 : SP_2015_RD0524_107_18_20150309_00027.jpg

Updated picture of the erosion site on the landside shoulder.

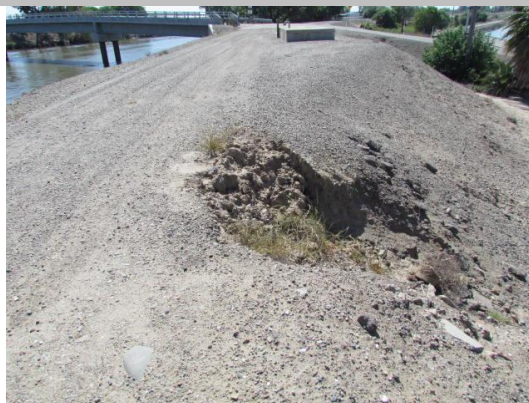
Photo 4 of 6 : SP_2015_RD0524_107_18_20150309_00028.jpg

Looking south at caving on landside shoulder. (Spring 2012)

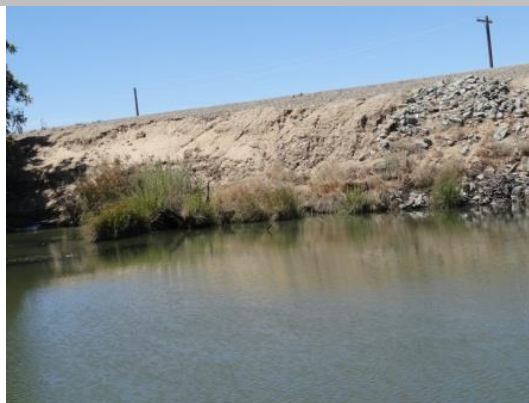
Photo 1 of 1 : SP_2015_RD0524_107_141_20150309_00137.jpg

LM Start	1.19	Rating **	U	Issue No.	141
LM End	1.19	Issue Type +	Ma	Location *	WS
Category	Supplemental			GPS Latitude/Longitude	
				Start	End
Item	DWR Erosion Survey			37.933347 °	37.933347 °
				-121.329110 °	-121.329110 °
DWR ID	DWR_RD0524_01_s_2015_141				
Action/Comments					
Inspector Comments: 6/19/2014: No significant change observed. 08/13/2013: No significant change at this site. 08/07/2012: The site has been visited by boat survey. No significant change observed 08/23/2011: No significant change observed on site. 9/07/2010: No significant change observed on site. Vegetation is visible at the water line. There is an exposed pipe discharge partially hanging at the mid-slope, possibly still used for discharging irrigation/runoff water. There is minimal rip rap protection along the bank, and what's left of it is no longer adequately protecting the bank. 9/29/2009: Site consists of a 400-foot long eroding bank with minimal vegetation and protection; the existing rip rap has sloughed, rendering it useless; note that there is an exposed section of a pipe. 10/18/2006: There is extensive loss of rip rap on some sections; sewage disposal pond is on the landside of the levee; there is an exposed pipe outlet "hanging" from the upper slope. [2014 Site ID:RD0524U01RM41.79]

Direct view of the site.

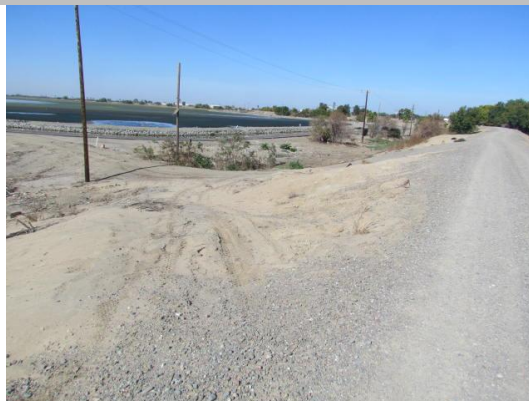
Photo 1 of 2 : SP_2015_RD0524_107_263_20150309_00157.jpg

LM Start	1.25	Rating **	U	Issue No.	263
LM End	1.25	Issue Type +	En	Location *	LS
Category	Earthen Levee			GPS Latitude/Longitude	
				Start	End
Item	Encroachments			37.932533 °	37.932533 °
				-121.328650 °	-121.328650 °
DWR ID	DWR_RD0524_01_s _ 2012_263				
Action/Comments					
Ramp					
Inspector Comments: Unauthorized ramps on landside slope. Ramps were caused by vehicle traffic.

Looking northwest at unauthorized ramp on landside slope.

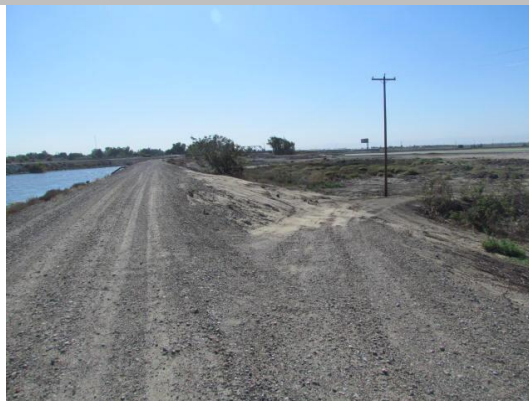
Photo 2 of 2 : SP_2015_RD0524_107_263_20150309_00158.jpg

Looking south at unauthorized ramp on landside slope.

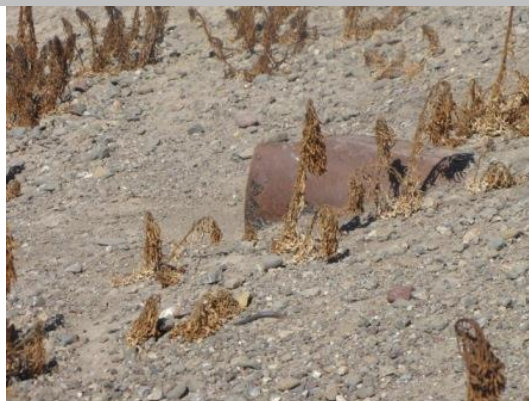
Photo 1 of 2 : SP_2015_RD0524_107_33_20150309_00046.jpg

LM Start	1.30	Rating **	M	Issue No.	33
LM End	1.30	Issue Type +	Ma	Location *	WS
Category	Earthen Levee			GPS Latitude/Longitude	
				Start	End
Item	Encroachments			37.931948 °	37.931948 °
				-121.328387 °	-121.328387 °
DWR ID	DWR_RD0524_01_s _ 2012_33				
Action/Comments					
Pipe Inspector Comments: Pipe is not in use and should be properly abandoned.

Looking west at pipe on landside slope.

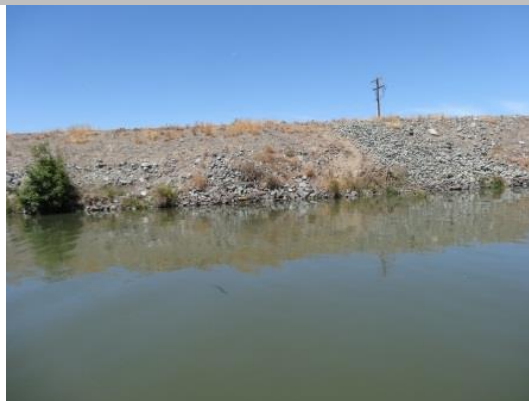
Photo 1 of 1 : SP_2015_RD0524_107_143_20150309_00139.jpg

LM Start	1.39	Rating **	U	Issue No.	143
LM End	1.39	Issue Type +	Ma	Location *	WS
Category	Supplemental			GPS Latitude/Longitude	
				Start	End
Item	DWR Erosion Survey			37.930575 °	37.930575 °
				-121.328090 °	-121.328090 °
DWR ID	DWR_RD0524_01_s _ 2015_143				
Action/Comments					
Inspector Comments: 6/19/2014: No significant change observed. 08/13/2013: No significant change observed. 08/07/2012: The site was first reported in 2012 spring levee inspection report. The site is located about 750 ft downstream of SR 4 Bridge. [2014 Site ID:RD0524U01RM42.03]

Front view of the erosion.

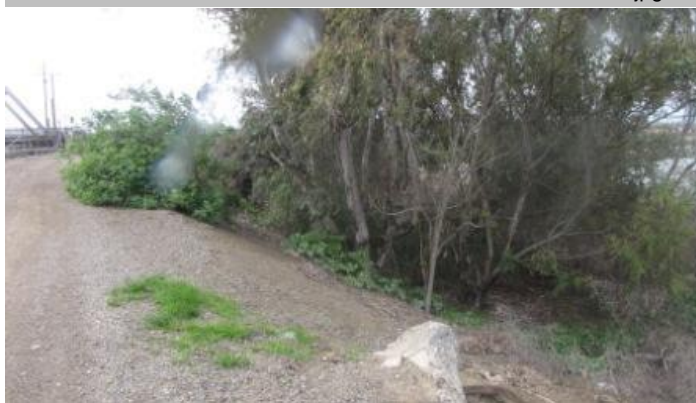
Photo 3 of 3 : SP_2015_RD0524_107_916_20150309_00167.jpg

Looking south at dense veg. on landside slope and toe.

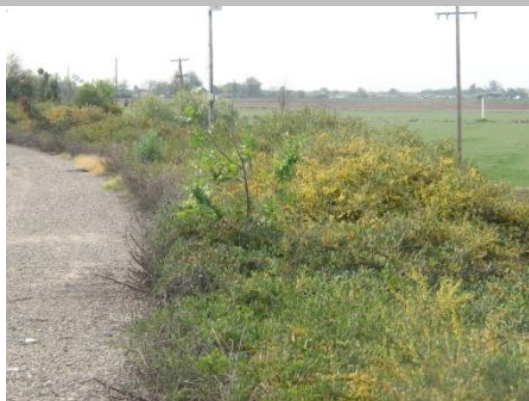
Photo 1 of 5 : SP_2015_RD0524_107_23_20150309_00034.jpg

Overgrown landscaping on landward slope from LM 1.56 to 1.74

LM Start	1.55	Rating **	A/W	Issue No.	23
LM End	1.59	Issue Type +	Ma	Location *	LS
Category	Earthen Levee			GPS Latitude/Longitude	
				Start	End
Item	Vegetation			37.928388 °	37.927797 °
				-121.328280 °	-121.327854 °
DWR ID	DWR_RD0524_01_s _ 2012_23				
Action/Comments					
Remove the wild growth other than native grasses from the levee slopes.

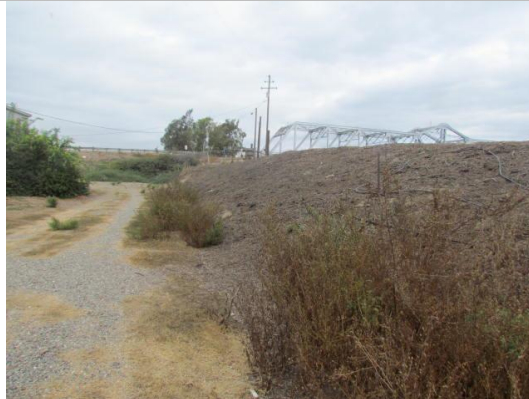
Photo 2 of 5 : SP_2015_RD0524_107_23_20150309_00035.jpg

Looking north from landward berm at corrected site.

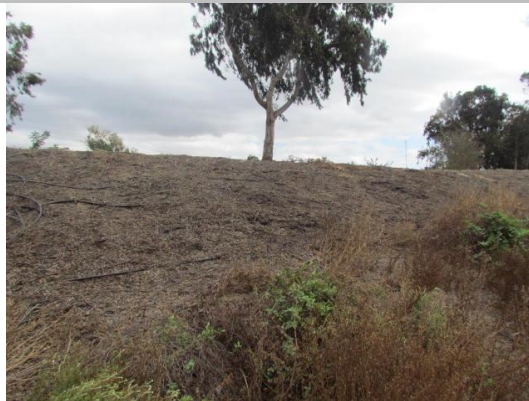
Photo 3 of 5 : SP_2015_RD0524_107_23_20150309_00036.jpg

Looking east from landward berm at corrected site.

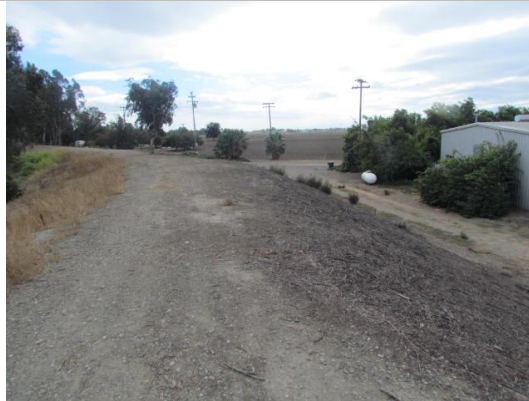
Photo 4 of 5 : SP_2015_RD0524_107_23_20150309_00037.jpg

Looking south from levee crown at corrected site.

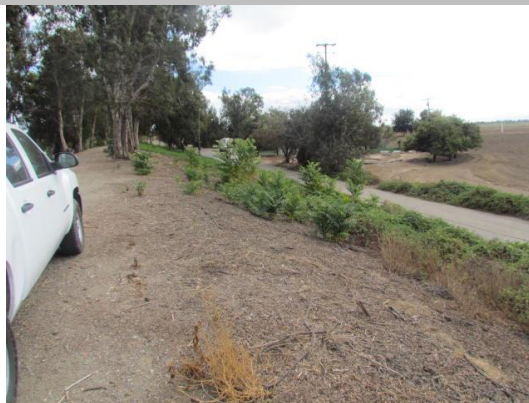
Photo 1 of 2 : SP_2015_RD0524_107_24_20150309_00039.jpg

Looking south at vegetation blocking view of landward toe.

LM Start	1.60	Rating **	M	Issue No.	24
LM End	1.61	Issue Type +	Ma	Location *	LS
Category	Earthen Levee			GPS Latitude/Longitude	
				Start	End
Item	Vegetation			37.927635 °	37.927540 °
				-121.327812 °	-121.327648 °
DWR ID	DWR_RD0524_01_s_2012_24				
Action/Comments					
Remove the wild growth other than native grasses from the levee slopes.					
Inspector Comments: Vegetation blocking landward toe.

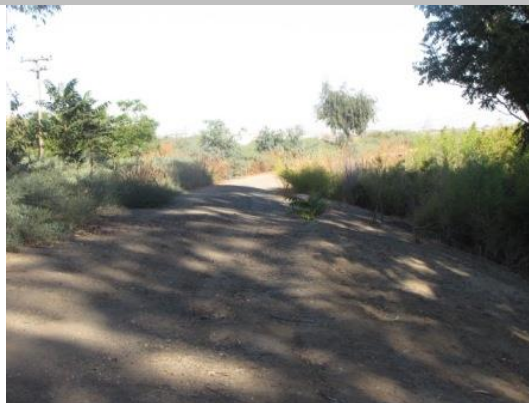
Photo 2 of 2 : SP_2015_RD0524_107_24_20150309_00040.jpg

Looking north at dense vegetation on the landside and waterside slopes.

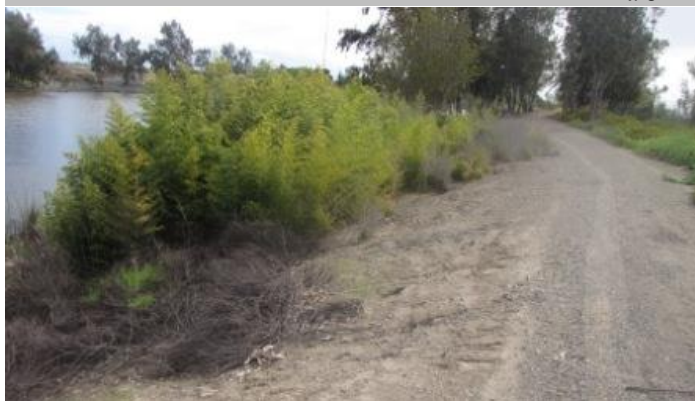
Photo 1 of 1 : SP_2015_RD0524_107_25_20150309_00041.jpg

Looking southeast at dense vegetation on the waterside slope.

LM Start	1.60	Rating **	A/W	Issue No.	25
LM End	1.61	Issue Type +	Ma	Location *	WS
Category	Earthen Levee			GPS Latitude/Longitude	
				Start	End
Item	Vegetation			37.927635 °	37.927540 °
				-121.327812 °	-121.327648 °
DWR ID	DWR_RD0524_01_s_2012_25				
Action/Comments					
Remove the wild growth other than native grasses from the levee slopes.

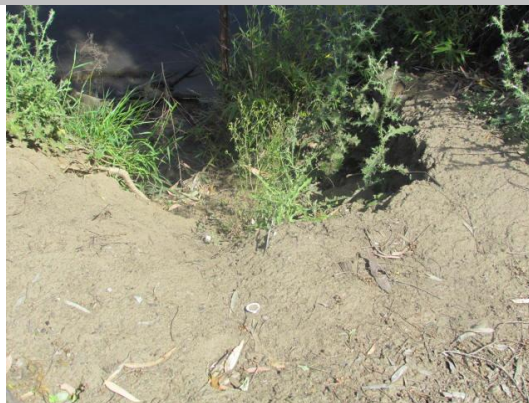
Photo 2 of 3 : SP_2015_RD0524_107_26_20150424_00215.jpg

Looking east at waterward erosion.

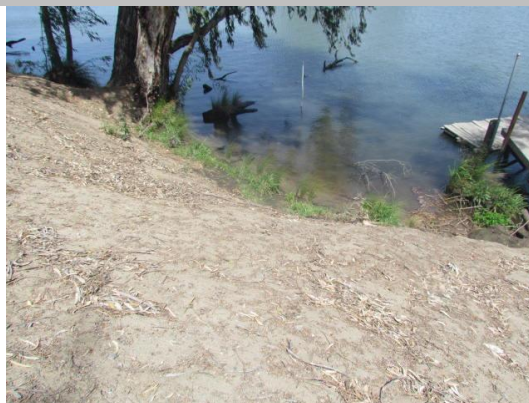
Photo 3 of 3 : SP_2015_RD0524_107_26_20150424_00216.jpg

Looking east at waterward erosion and depression.

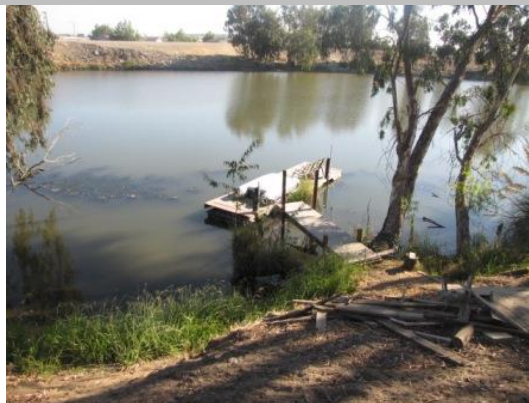
Photo 2 of 2 : SP_2015_RD0524_107_39_20150309_00058.jpg

LM Start	1.64	Rating **	U	Issue No.	39
LM End	1.64	Issue Type +	En	Location *	WS
Category	Earthen Levee			GPS Latitude/Longitude	
				Start	End
Item	Encroachments			37.927372 °	37.927372 °
				-121.327278 °	-121.327278 °
DWR ID	DWR_RD0524_01_s _ 2012_39				
Action/Comments					
Pole					
Inspector Comments: Landowner constructed boat dock without permission from the CVFPB.

Looking east at non-permitted boat dock.

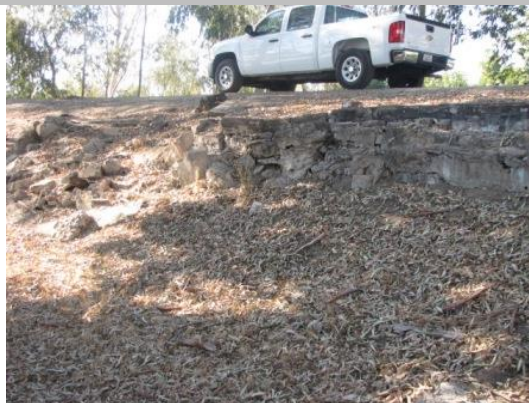
Photo 2 of 3 : SP_2015_RD0524_107_45_20150309_00063.jpg

Looking southwest at retaining wall connected to concrete stairs.

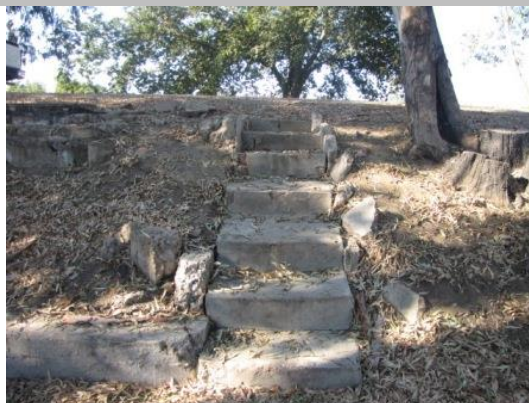
Photo 3 of 3 : SP_2015_RD0524_107_45_20150309_00064.jpg

Looking west at concrete stairs on waterside slope.

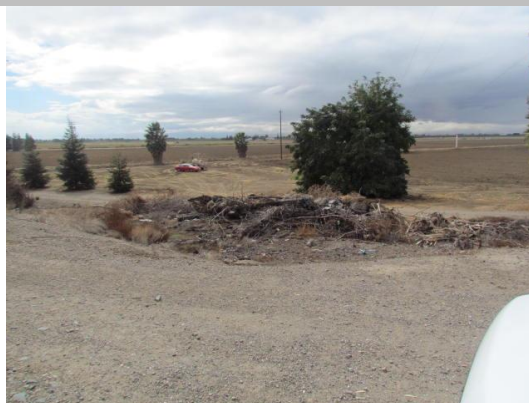
Photo 1 of 2 : SP_2015_RD0524_107_28_20150309_00042.jpg

LM Start	1.73	Rating **	A/W	Issue No.	28
LM End	1.73	Issue Type +	Ma	Location *	LS
Category	Earthen Levee			GPS Latitude/Longitude	
				Start	End
Item	Encroachments			37.926322 °	37.926322 °
				-121.326115 °	-121.326115 °
DWR ID	DWR_RD0524_01_s _ 2012_28				
Action/Comments					
Garbage Inspector Comments: Large pruning piles on landside slope.

Looking southwest at trash and a pruning pile on landward berm.

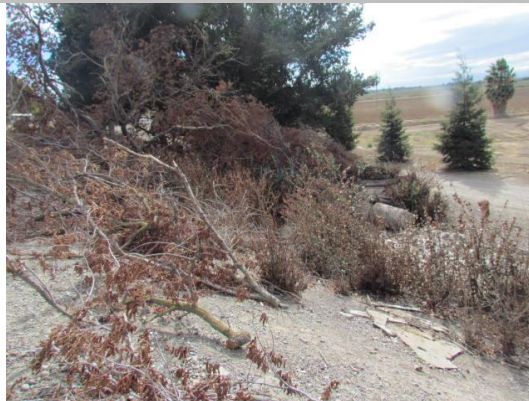
Photo 2 of 4 : SP_2015_RD0524_107_46_20150309_00066.jpg

Looking southwest at tree limbs on landward slope.

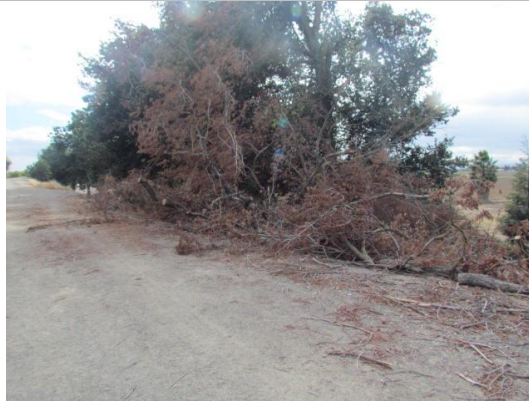
Photo 3 of 4 : SP_2015_RD0524_107_46_20150309_00067.jpg

Looking south at tree limbs on landward slope.

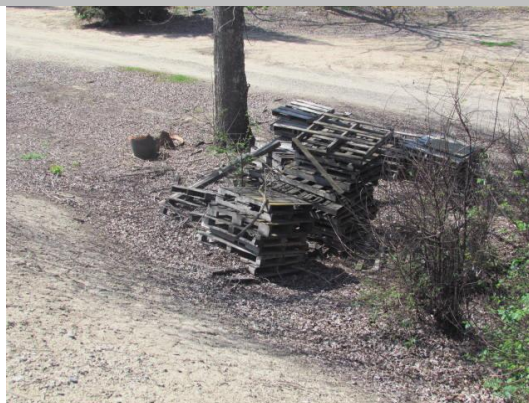
Photo 1 of 1 : SP_2015_RD0524_107_181_20150309_00149.jpg

LM Start	1.76	Rating **	A/W	Issue No.	181
LM End	1.76	Issue Type +	Ma	Location *	N/A
Category	Earthen Levee			GPS Latitude/Longitude	
				Start	End
Item	Encroachments			37.925972 °	37.925972 °
				-121.325769 °	-121.325769 °
DWR ID	DWR_RD0524_01_s _ 2014_181				
Action/Comments					
Material					
Inspector Comments: Landowner stockpiling pallets at landward toe.

Looking west at wooden pallets at landward toe.

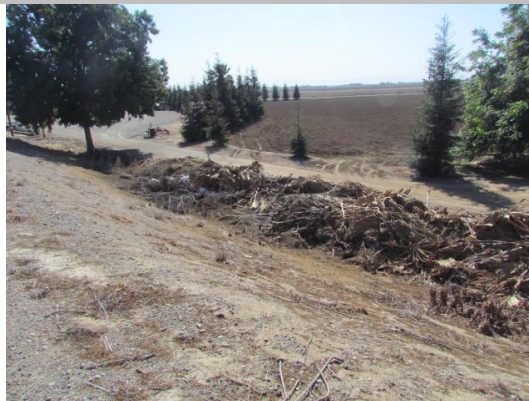
Photo 1 of 1 : SP_2015_RD0524_107_100_20150309_00103.jpg

LM Start	1.78	Rating **	A/W	Issue No.	100
LM End	1.78	Issue Type +	Ma	Location *	LS
Category	Earthen Levee			GPS Latitude/Longitude	
				Start	End
Item	Encroachments			37.925752 °	37.925752 °
				-121.325592 °	-121.325592 °
DWR ID	DWR_RD0524_01_s _ 2012_100				
Action/Comments					
Prunings

Looking southwest at prunings on landside toe.

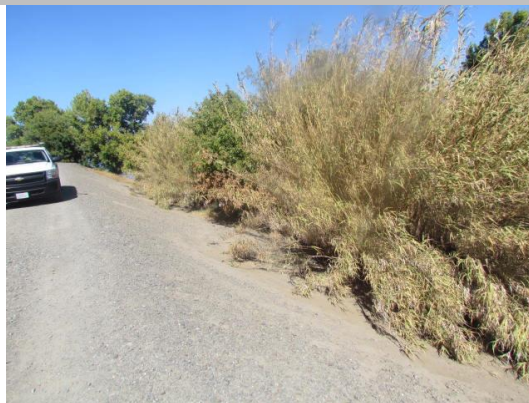
Photo 1 of 2 : SP_2015_RD0524_107_104_20150309_00106.jpg

LM Start	1.94	Rating **	A/W	Issue No.	104
LM End	1.94	Issue Type +	En	Location *	WS
Category	Earthen Levee			GPS Latitude/Longitude	
				Start	End
Item	Vegetation			37.923808 °	37.923808 °
				-121.324260 °	-121.324260 °
DWR ID	DWR_RD0524_01_s _ 2012_104				
Action/Comments					
Remove the wild growth other than native grasses from the levee slopes. Inspector Comments: Bamboo outside of the twenty foot vegetation zone.

Looking northeast at sprayed bamboo on waterside slope. (Fall 2012)

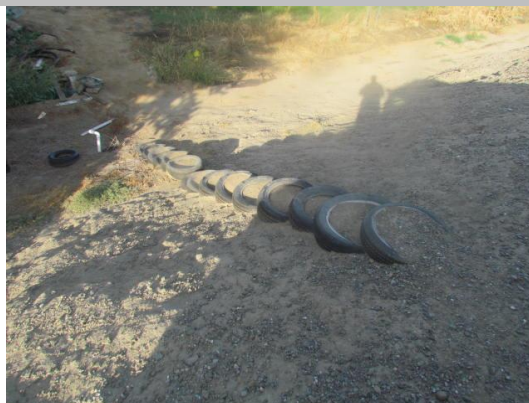
Photo 1 of 1 : SP_2015_RD0524_107_4_20150309_00009.jpg

LM Start	1.99	Rating **	M	Issue No.	4
LM End	1.99	Issue Type +	En	Location *	LS
Category	Earthen Levee			GPS Latitude/Longitude	
				Start	End
Item	Encroachments			37.923068 °	37.923068 °
				-121.323990 °	-121.323990 °
DWR ID	DWR_RD0524_01_f_2012_4				
Action/Comments					
Stairway Inspector Comments: Landowner installed rubber tires for a stairway on landside slope.

Looking west at rubber tires being used as stairs on landside slope.

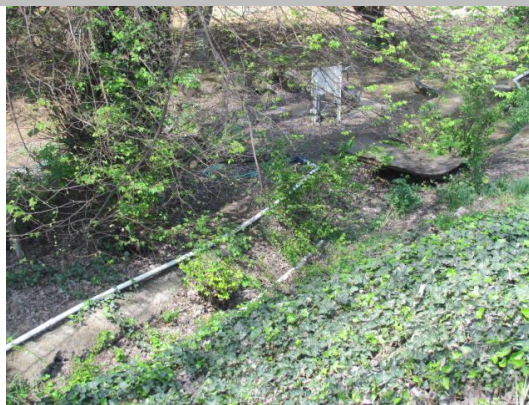
Photo 1 of 2 : SP_2015_RD0524_107_182_20150309_00150.jpg

LM Start	2.01	Rating **	M	Issue No.	182
LM End	2.04	Issue Type +	En	Location *	LS
Category	Earthen Levee			GPS Latitude/Longitude	
				Start	End
Item	Encroachments			37.922837 °	37.922514 °
				-121.323785 °	-121.323504 °
DWR ID	DWR_RD0524_01_s_2014_182				
Action/Comments					
Ditch Inspector Comments: Old irrigation ditch at the landward toe should be removed.

Looking northwest at an old irrigation ditch at landward toe.

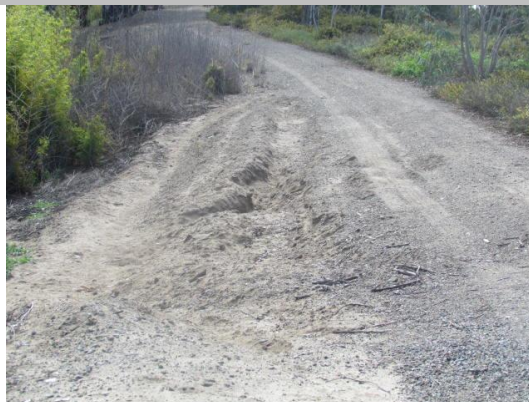
Photo 1 of 1 : SP_2015_RD0524_107_31_20150309_00044.jpg

LM Start	2.19	Rating **	M	Issue No.	31
LM End	2.25	Issue Type +	Ma	Location *	WS
Category	Earthen Levee			GPS Latitude/Longitude	
				Start	End
Item	Slope Stability			37.920992 °	37.920505 °
				-121.321373 °	-121.320485 °
DWR ID	DWR_RD0524_01_s_2012_31				
Action/Comments					
Repair slope instability.

Looking south slope damage on waterward shoulder and slope.

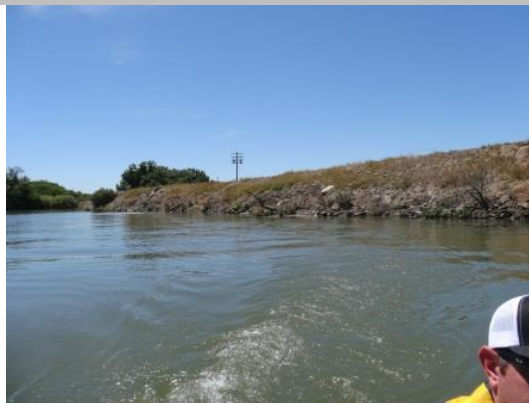
Photo 1 of 1 : SP_2015_RD0524_107_146_20150309_00142.jpg

LM Start	2.19	Rating **	U	Issue No.	146
LM End	2.19	Issue Type +	Ma	Location *	WS
Category	Supplemental			GPS Latitude/Longitude	
				Start	End
Item	DWR Erosion Survey			37.920992 °	37.920992 °
				-121.321370 °	-121.321370 °
DWR ID	DWR_RD0524_01_s _ 2015_146				
Action/Comments					
Inspector Comments: 7/22/2014: The erosion has increased in size. 08/13/2013: No significant change observed. Slightly more vegetation was visible. 08/07/2012: The site was first reported in 2012 spring levee inspection report. [2014 Site ID:RD0524U01RM42.79]

View from downstream.

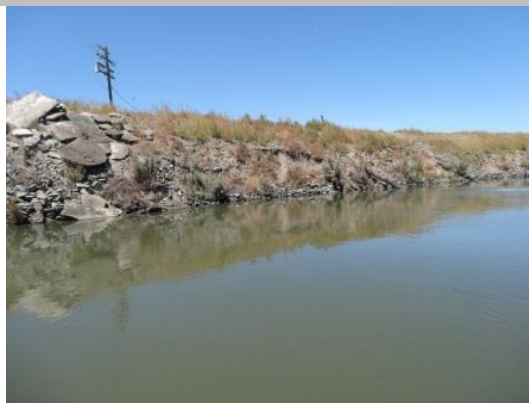
Photo 1 of 1 : SP_2015_RD0524_107_147_20150309_00143.jpg

LM Start	2.25	Rating **	U	Issue No.	147
LM End	2.25	Issue Type +	Ma	Location *	WS
Category	Supplemental			GPS Latitude/Longitude	
				Start	End
Item	DWR Erosion Survey			37.920650 °	37.920650 °
				-121.320370 °	-121.320370 °
DWR ID	DWR_RD0524_01_s _ 2015_147				
Action/Comments					
Inspector Comments: 6/19/2014: No significant change observed. 08/13/2013: An irrigation pipe is on site. [2014 Site ID:RD0524U01RM42.84]

View from upstream.

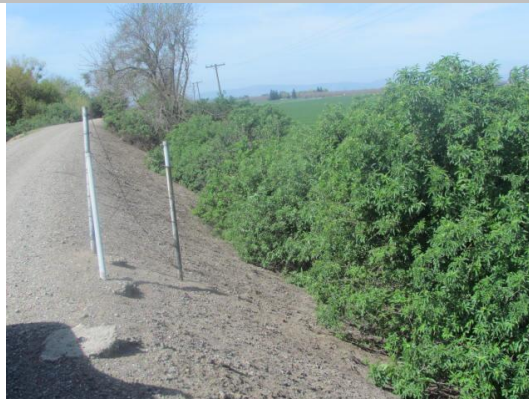
Photo 1 of 1 : SP_2015_RD0524_107_35_20150309_00049.jpg

LM Start	2.41	Rating **	U	Issue No.	35
LM End	2.45	Issue Type +	Ma	Location *	LS
Category	Earthen Levee			GPS Latitude/Longitude	
				Start	End
Item	Vegetation			37.918785 °	37.918515 °
				-121.320417 °	-121.321110 °
DWR ID	DWR_RD0524_01_s _ 2012_35				
Action/Comments					
Elderberries are blocking visibility and flood fight capability.

Looking southwest at dense vegetation on landward toe.

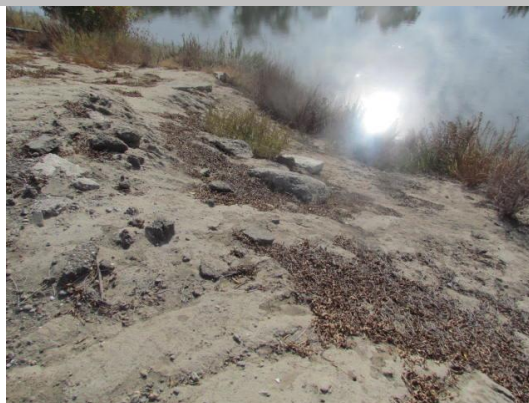
Photo 1 of 1 : SP_2015_RD0524_107_36_20150309_00050.jpg

LM Start	2.44	Rating **	M	Issue No.	36
LM End	2.47	Issue Type +	Ma	Location *	WS
Category	Earthen Levee			GPS Latitude/Longitude	
				Start	End
Item	Erosion / Bank Caving			37.918628 °	37.918438 °
				-121.320817 °	-121.321452 °
DWR ID	DWR_RD0524_01_s _ 2012_36				
Action/Comments					
Note and monitor erosion site.

Looking east at erosion on waterside slope.

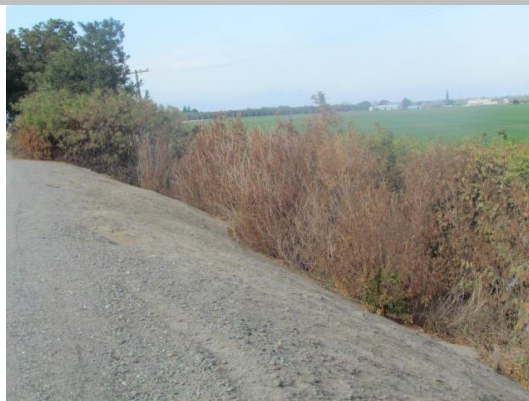
Photo 1 of 2 : SP_2015_RD0524_107_80_20150309_00092.jpg

LM Start	2.45	Rating **	M	Issue No.	80
LM End	2.45	Issue Type +	Ma	Location *	LS
Category	Earthen Levee			GPS Latitude/Longitude	
				Start	End
Item	Trim / Thin Trees			37.918480 °	37.918480 °
				-121.321114 °	-121.321114 °
DWR ID	DWR_RD0524_01_s _ 2012_80				
Action/Comments					
Trim trees to at least five feet above ground level.

Looking southwest at dense vegetation and trees on landside slope.
(Fall 2012)

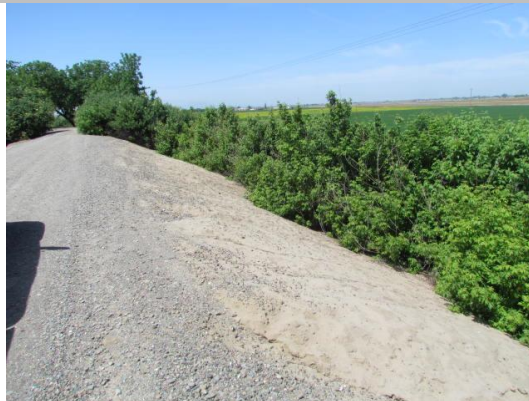
Photo 2 of 2 : SP_2015_RD0524_107_80_20150309_00093.jpg

LM Start	2.45	Rating **	M	Issue No.	80 (cont)	
LM End	2.45	Issue Type +	Ma	Location *	LS	
Category	Earthen Levee			GPS Latitude/Longitude		
				Start		End
Item	Trim / Thin Trees			37.918480 °	37.918480 °	
				-121.321114 °	-121.321114 °	
DWR ID	DWR_RD0524_01_s_2012_80					
Action/Comments						
Trim trees to at least five feet above ground level.

Looking southwest at dense vegetation on landside toe.

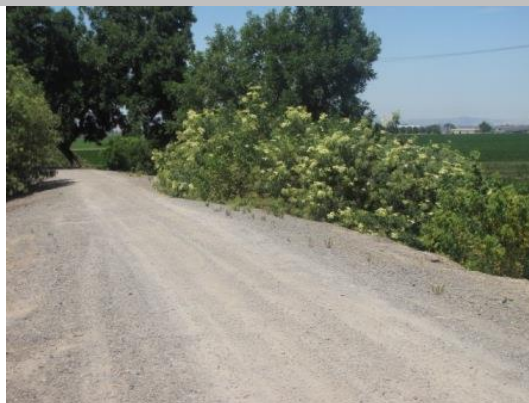
Photo 1 of 4 : SP_2015_RD0524_107_37_20150309_00051.jpg

LM Start	2.49	Rating **	U	Issue No.	37
LM End	2.50	Issue Type +	Ma	Location *	LS
Category	Earthen Levee			GPS Latitude/Longitude	
				Start	End
Item	Vegetation			37.918345 °	37.918302 °
				-121.321765 °	-121.321923 °
DWR ID	DWR_RD0524_01_s_2012_37				
Action/Comments					
Elderberries are blocking visibility and flood fight capability.

Looking south at elderberry on landside slope.

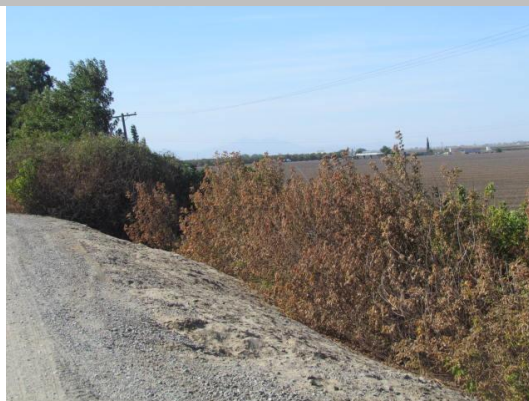
Photo 2 of 4 : SP_2015_RD0524_107_37_20150309_00052.jpg

LM Start	2.49	Rating **	U	Issue No.	37 (cont)
LM End	2.50	Issue Type +	Ma	Location *	LS

Looking southwest at dense vegetation on landside toe.

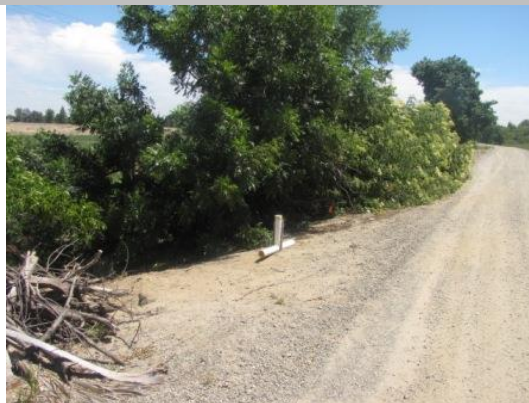
Photo 3 of 4 : SP_2015_RD0524_107_37_20150309_00053.jpg

LM Start	2.49	Rating **	U	Issue No.	37 (cont)
LM End	2.50	Issue Type +	Ma	Location *	LS
Category	Earthen Levee			GPS Latitude/Longitude	
				Start	End
Item	Vegetation			37.918345 °	37.918302 °
				-121.321765 °	-121.321923 °
DWR ID	DWR_RD0524_01_s _ 2012_37				
Action/Comments					
Elderberries are blocking visibility and flood fight capability.

Looking north at elderberry and trees on landside slope.

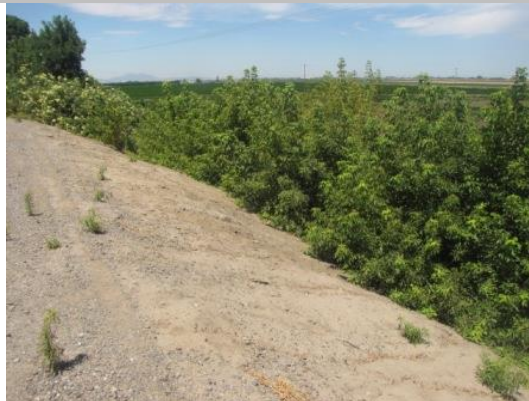
Photo 4 of 4 : SP_2015_RD0524_107_37_20150309_00054.jpg

LM Start	2.49	Rating **	U	Issue No.	37 (cont)
LM End	2.50	Issue Type +	Ma	Location *	LS

Looking southwest at trees along levee landside toe.

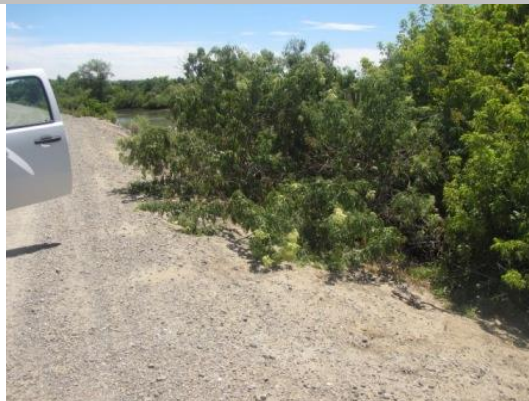
Photo 1 of 2 : SP_2015_RD0524_107_38_20150309_00055.jpg

LM Start	2.50	Rating **	U	Issue No.	38
LM End	2.50	Issue Type +	Ma	Location *	WS
Category	Earthen Levee			GPS Latitude/Longitude	
				Start	End
Item	Vegetation			37.918287 °	37.918287 °
				-121.321980 °	-121.321980 °
DWR ID	DWR_RD0524_01_s _ 2012_38				
Action/Comments					
Elderberries are blocking visibility and flood fight capability.

Looking north at elderberry on waterside slope.

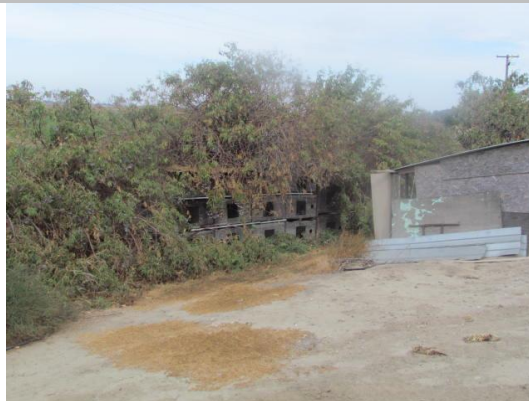
Photo 1 of 2 : SP_2015_RD0524_107_42_20150309_00059.jpg

LM Start	2.56	Rating **	U	Issue No.	42
LM End	2.56	Issue Type +	En	Location *	WS
Category	Earthen Levee			GPS Latitude/Longitude	
				Start	End
Item	Encroachments			37.917673 °	37.917673 °
				-121.322718 °	-121.322718 °
DWR ID	DWR_RD0524_01_s_2012_42				
Action/Comments					
Building Inspector Comments: Animal pens on landward slope and toe.

Looking west at animal pens on landside toe. (Fall 2012)

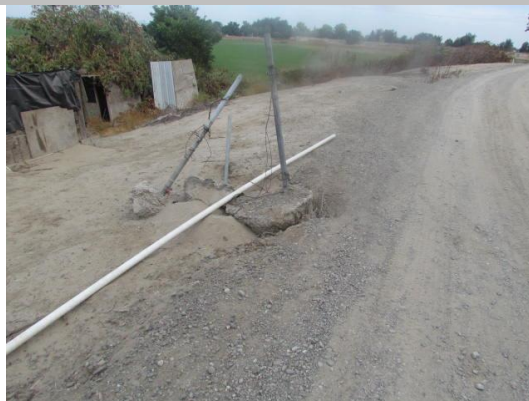
Photo 1 of 1 : SP_2015_RD0524_107_12_20150309_00016.jpg

LM Start	2.57	Rating **	M	Issue No.	12
LM End	2.57	Issue Type +	En	Location *	LS
Category	Earthen Levee			GPS Latitude/Longitude	
				Start	End
Item	Encroachments			37.917538 °	37.917538 °
				-121.322757 °	-121.322757 °
DWR ID	DWR_RD0524_01_f_2012_12				
Action/Comments					
Pole					
Inspector Comments: Old fence poles on landside shoulder and slope should be removed.

Looking northwest at fence poles on landside shoulder.

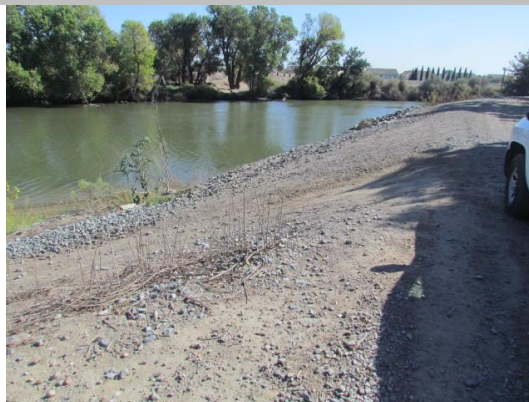
Photo 1 of 1 : SP_2015_RD0524_107_920_20150309_00168.jpg

LM Start	2.65	Rating **	U	Issue No.	920
LM End	2.65	Issue Type +	En	Location *	WS
Category	Earthen Levee			GPS Latitude/Longitude	
				Start	End
Item	Encroachments			37.916698 °	37.916698 °
				-121.322007 °	-121.322007 °
DWR ID	DWR_RD0524_01_s _ 2012_920				
Action/Comments					
Ramp

Looking southeast at unauthorized ramp on waterside slope.

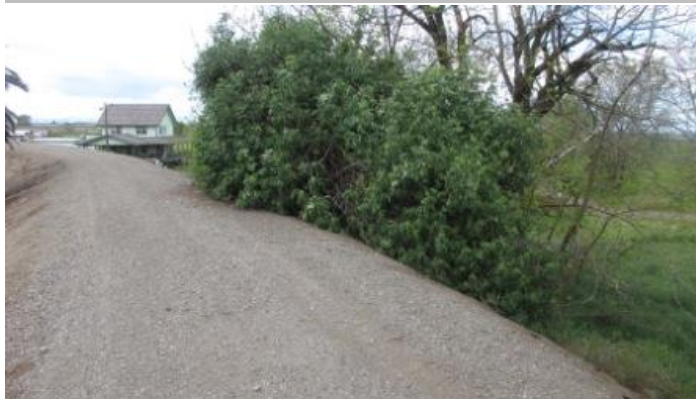
Photo 2 of 2 : SP_2015_RD0524_107_48_20150309_00070.jpg

LM Start	2.80	Rating **	U	Issue No.	48 (cont)	
LM End	2.80	Issue Type +	Ma	Location *	LS	
Category	Earthen Levee			GPS Latitude/Longitude		
				Start		End
Item	Vegetation			37.915022 °		37.915022 °
				-121.323443 °		-121.323443 °
DWR ID	DWR_RD0524_01_s _ 2012_48					
Action/Comments						
Elderberries are blocking visibility and flood fight capability.

Looking south at elderberry on landside slope.(Spring 2011)

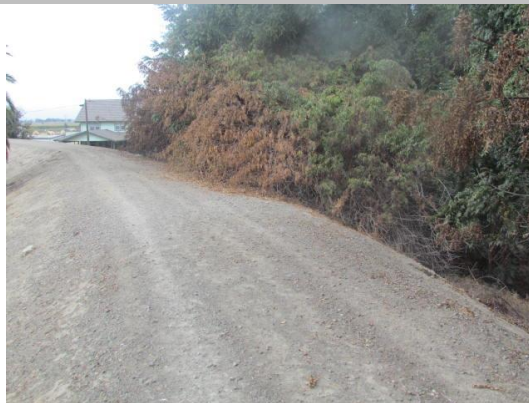
Photo 1 of 1 : SP_2015_RD0524_107_91_20150309_00096.jpg

LM Start	2.80	Rating **	U	Issue No.	91
LM End	2.80	Issue Type +	Ma	Location *	LS
Category	Earthen Levee			GPS Latitude/Longitude	
				Start	End
Item	Trim / Thin Trees			37.915063 °	37.915063 °
				-121.323585 °	-121.323585 °
DWR ID	DWR_RD0524_01_s _ 2012_91				
Action/Comments					
Thin trees to allow visibility of the ground and room to flood fight.

Looking southwest at dense vegetation on landside slope.

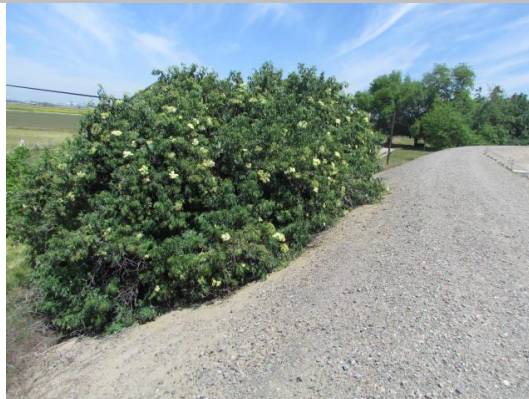
Photo 1 of 1 : SP_2015_RD0524_107_49_20150309_00071.jpg

LM Start	2.86	Rating **	U	Issue No.	49
LM End	2.86	Issue Type +	Ma	Location *	LS
Category	Earthen Levee			GPS Latitude/Longitude	
				Start	End
Item	Vegetation			37.914427 °	37.914427 °
				-121.324198 °	-121.324198 °
DWR ID	DWR_RD0524_01_s _ 2012_49				
Action/Comments					
Elderberries are blocking visibility and flood fight capability.

Looking northwest at elderberry on landside slope.
